Report of Geotechnical Investigation Dam Safety Assessment of Coal Combustion Surface Impoundments Minnesota Power Boswell Energy Center, Cohasset, MN

AMEC Project No. 3-2106-0174.0300

June 2010

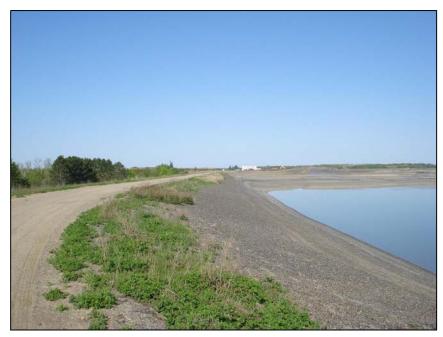
1-1
FROM CREST OF SOUTHEAST DIKE LOOKING WEST TOWARDS BOTTOM ASH POND

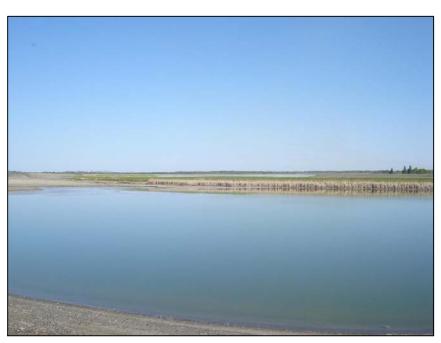
1-2
FROM CREST OF SOUTHEAST DIKE LOOKING NORTH TOWARDS BOTTOM ASH POND

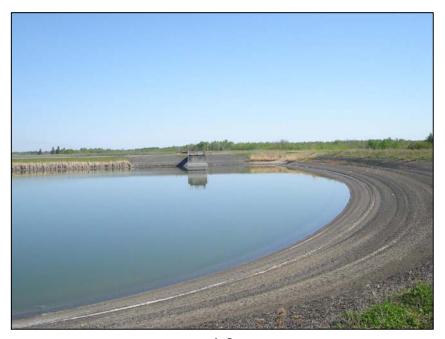
1-3 FROM CREST OF SOUTHEAST DIKE LOOKING NORTHEAST TOWARDS BOTTOM ASH POND

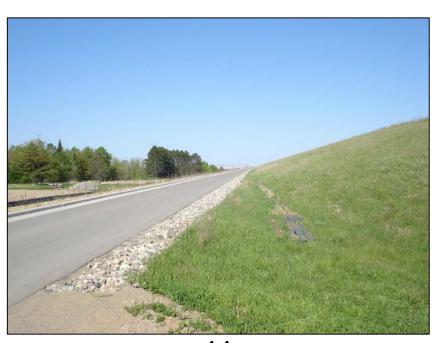
1-4 FROM OLD ROUTE 6 ALONG SOUTHEAST DIKE LOOKING WEST

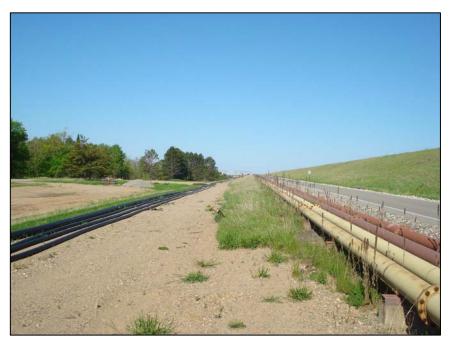
1-5 FROM TOE OF SOUTHEAST DIKE LOOKING WEST

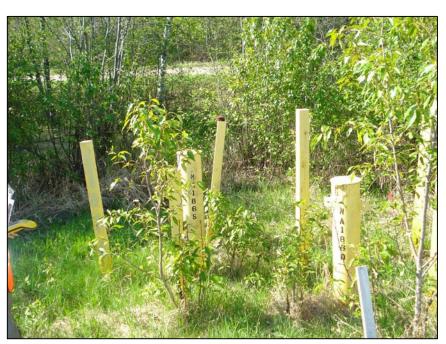
1-6 MONITORING WELLS NA186S AND NA186D

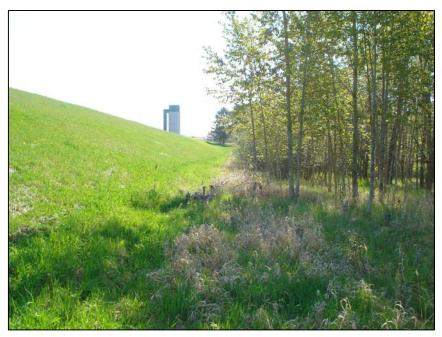
1-7 WETLAND AREA ALONG SOUTHERN DOWNSTREAM TOE

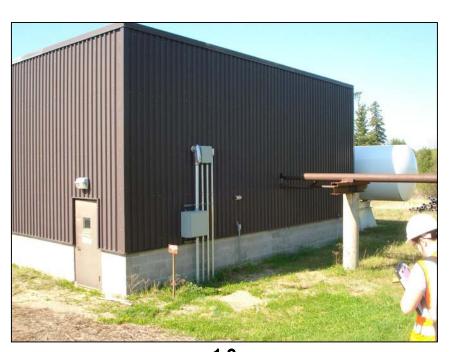
1-8 **INACTIVE INTAKE STRUCTURE**

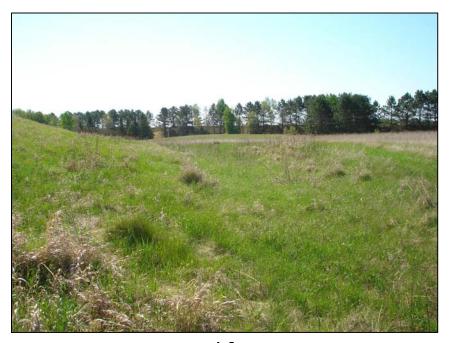
1-9 WETLAND AREA ALONG SOUTHERN DOWNSTREAM TOE

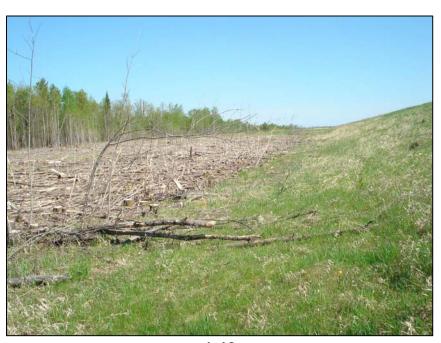
1-10 CLEARED AREA ALONG WESTERN DOWNSTREAM TOE

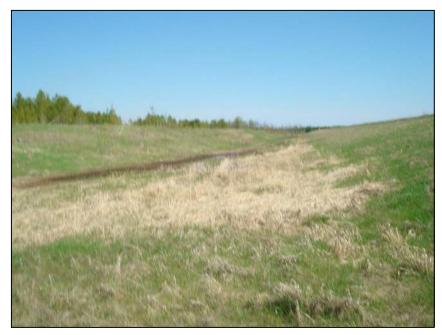
1-11 LOW AREA ALONG WESTERN DOWNSTREAM TOE

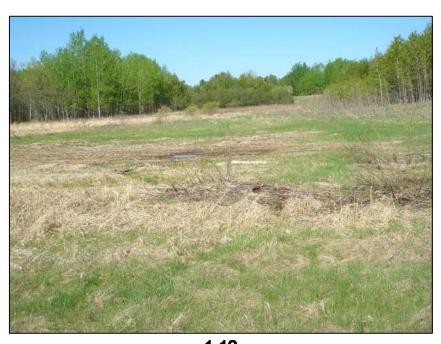
1-12
WET AREA ALONG WESTERN DOWNSTREAM TOE

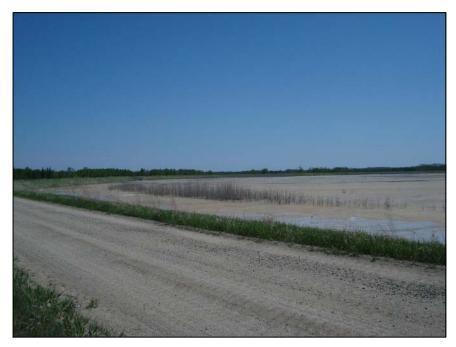
1-13
VIEW FROM WESTERN DIKE LOOKING NORTHEAST TOWARDS POND 4

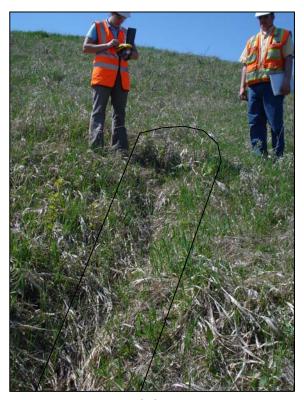
1-15 SWALE ALONG SOUTHERN DOWNSTREAM SLOPE

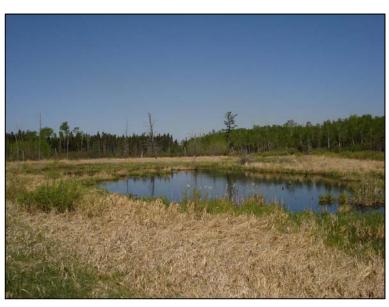
1-16 WETLAND AREA ALONG NORTHWESTERN DOWNSTREAM TOE

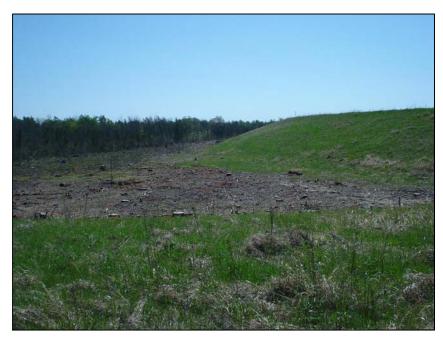
1-17
CLEARED AREA ALONG NORTHEASTERN DOWNSTREAM TOE

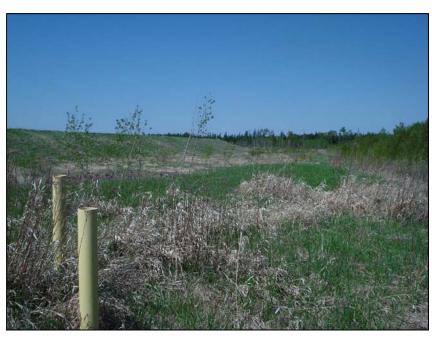
1-18
LOW AREA ALONG EASTERN DOWNSTREAM TOE

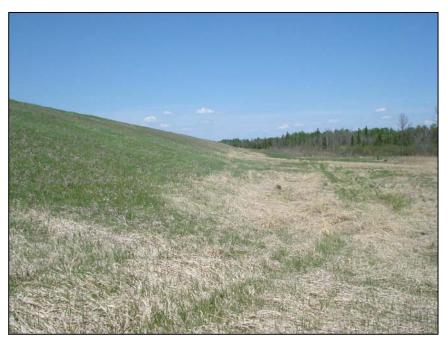
1-19
GENERAL SITE PHOTO FROM EASTERN DOWNSTREAM TOE LOOKING NORTH

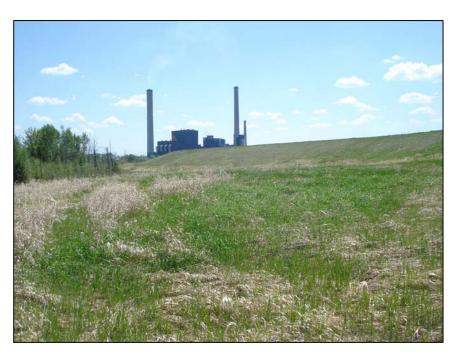
1-20
FROM EASTERN DOWNSTREAM TOE LOOKING SOUTHEAST TOWARDS BOSWELL ENERGY CENTER

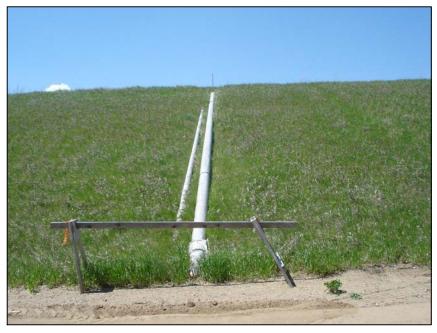
1-21
DISCHARGE LINES FROM PUMP HOUSE ALONG SOUTHEASTERN TOE

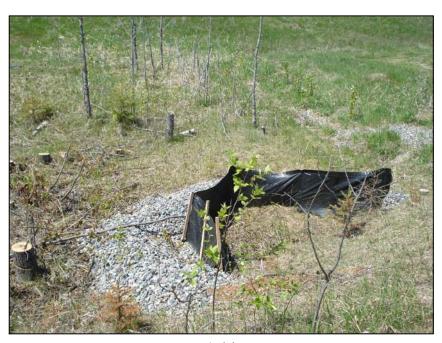
1-22
EROSION CONTROL EFFORTS ALONG SOUTHEASTERN DOWNSTREAM TOE

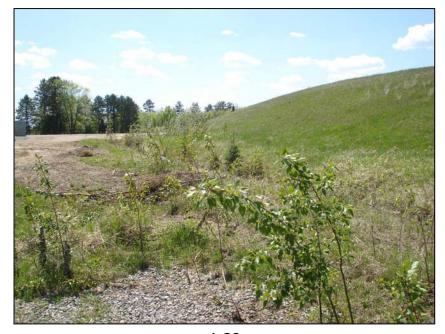
1-23
GENERAL SITE PHOTO ALONG SOUTHEASTERN DOWNSTREAM TOE

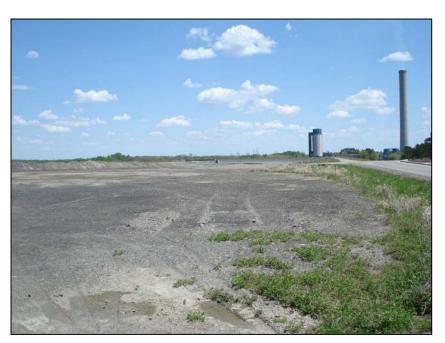
1-24
VIEW FROM SOUTHERN DIKE ALONG BOTTOM ASH POND LOOKING EAST TOWARDS BOTTOM ASH POND

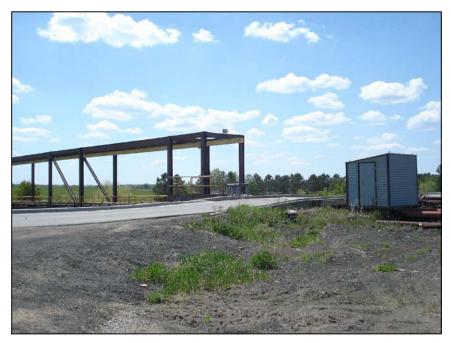
1-25
INTAKE STRUCTURE FOR BOTTOM ASH POND DISCHARGE LINES

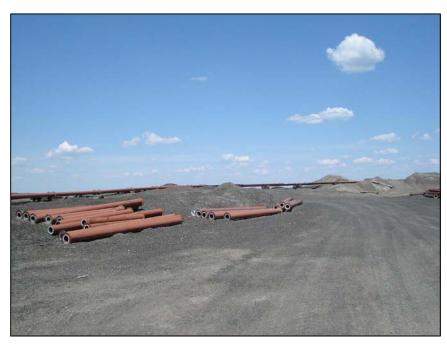
1-26
VIEW FROM SOUTHERN DIKE ALONG BOTTOM ASH POND LOOKING NORTH

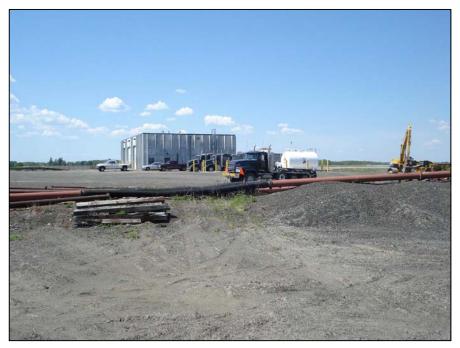
MAINTENANCE STRUCTURE IN BOTTOM ASH POND, DISCHARGE LINES IN FOREGROUND

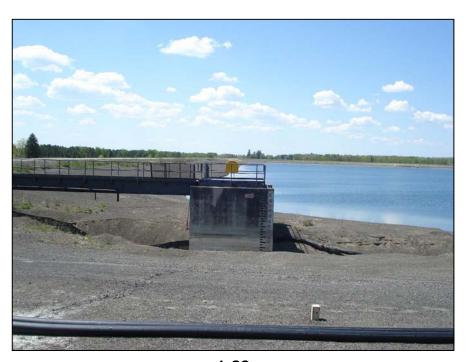
1-28 **OUTLET STRUCTURE FROM POND 3**

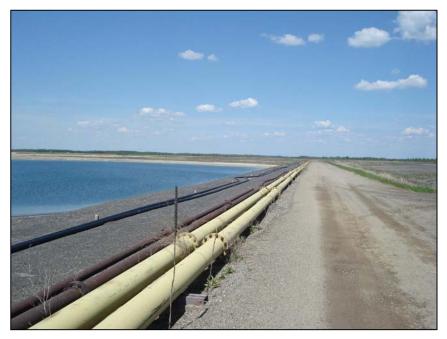
1-29
VIEW FROM DIVIDING DIKE BETWEEN BOTTOM ASH POND AND POND 3 LOOKING NORTH

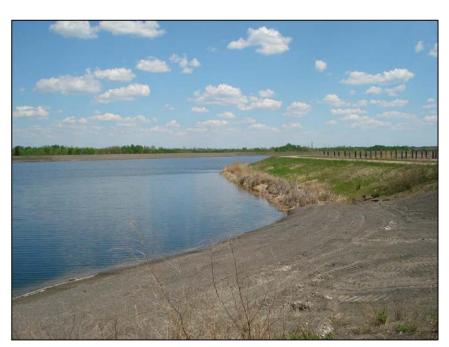
$\begin{tabular}{ll} $1-30$ \\ \hline VIEW FROM DIVIDING DIKE AT INTERSECTION OF BOTTOM ASH POND, POND 3 AND POND 4 LOOKING WEST\\ \end{tabular}$

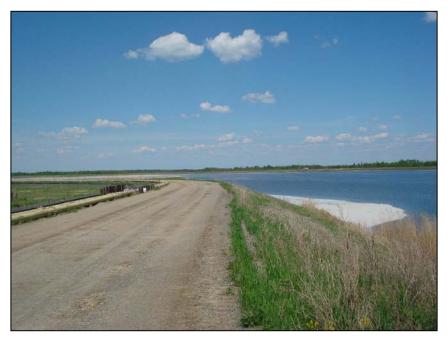
1--31 VIEW FROM DIVIDING DIKE AT INTERSECTION OF BOTTOM ASH POND, POND 3 AND POND 4 LOOKING NORTH

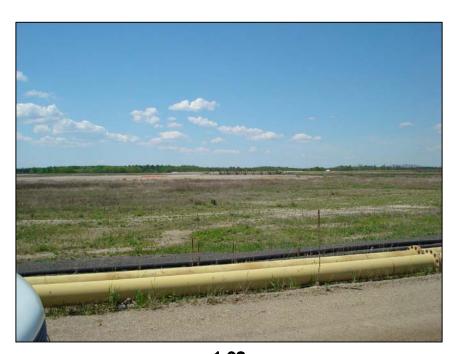
1-32
VIEW FROM DIVIDING DIKE BETWEEN POND 3 AND POND 4 LOOKING SOUTH

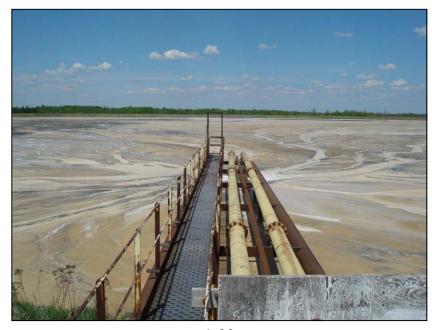
1-33
DISCHARGE STRUCTURE FROM PLANT TO POND 4

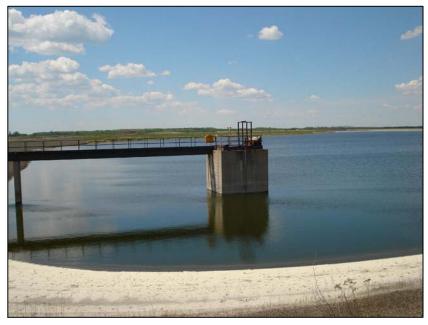
1-37 **OUTLET STRUCTURE FOR POND 4**

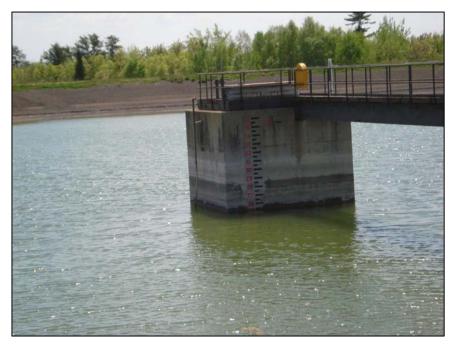
1-39
OUTLET STRUCTURE FOR BOTTOM ASH POND

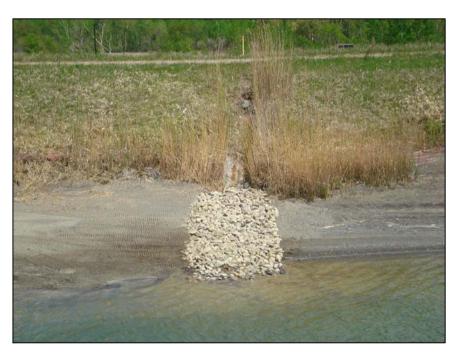
1-40
OUTLET DRAIN FOR PUMP HOUSE ALONG SOUTHEASTERN DOWNSTREAM TOE

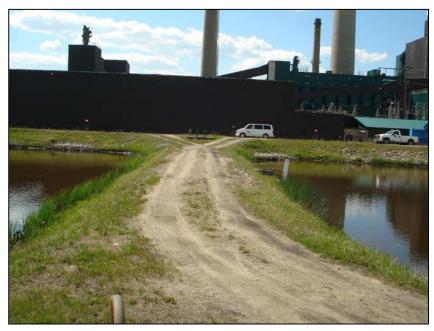
2-1 GENERAL SITE PHOTO FROM CENTER OF POND LOOKING WEST

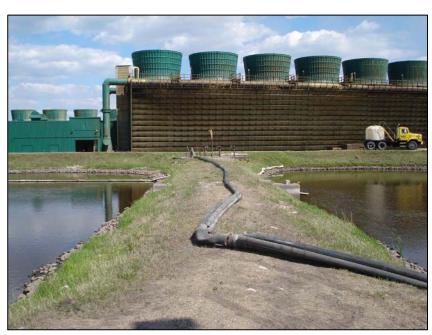
GENERAL SITE PHOTO FROM CENTER OF POND LOOKING EAST

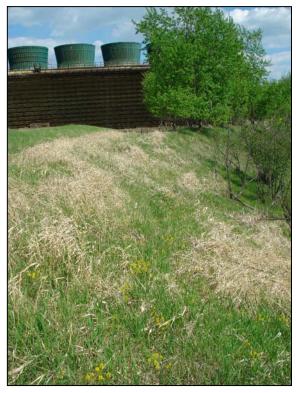
VIEW ALONG OUTFALL (SD004) LOOKING EAST

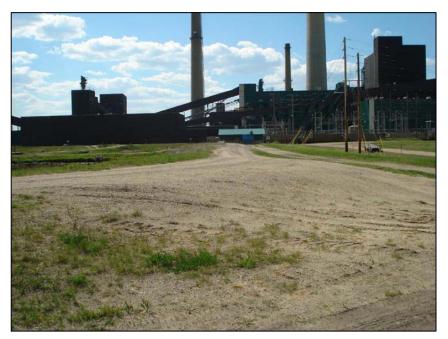
2-5
FROM NORTHEASTERN EDGE OF WWTP LOOKING WEST TOWARDS PLANT

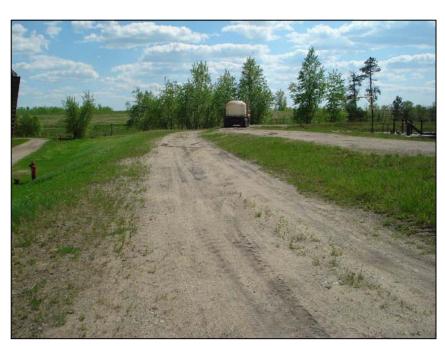
2-6
FROM NORTHEATERN EDGE OF WWTP LOOKING EAST

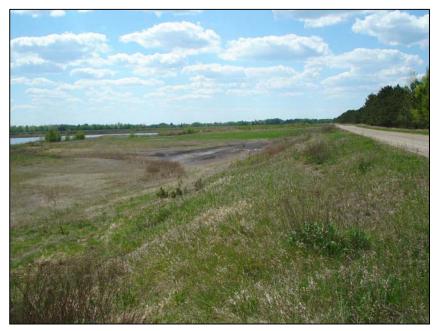
$\begin{array}{c} \textbf{3-1} \\ \textbf{GENERAL SITE PHOTO FROM NORTHERN DIKE LOOKING WEST} \end{array}$

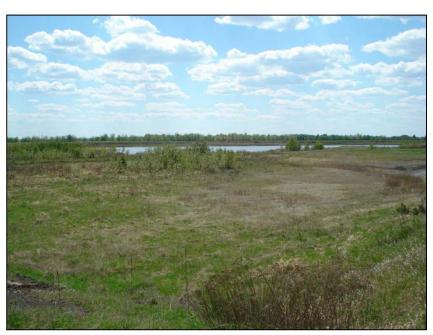
3-2
GENERAL SITE PHOTO FROM NORTHERN DIKE LOOKING NORTHWEST

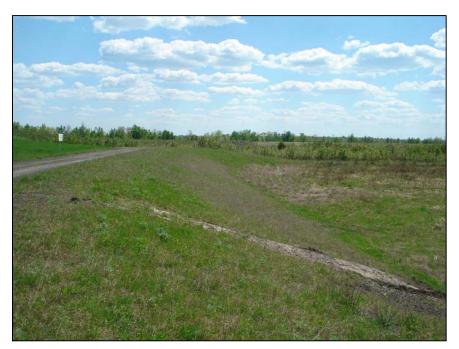
$\begin{array}{c} \textbf{3-3} \\ \textbf{GENERAL SITE PHOTO FROM NORTHERN DIKE LOOKING NORTH} \end{array}$

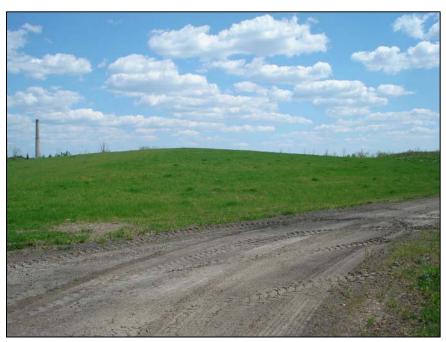
3-4
GENERAL SITE PHOTO FROM NORTHERN DIKE LOOKING EAST TOWARDS THE CLOSED HIBBING PUBLIC UTILITIES ASH CELL

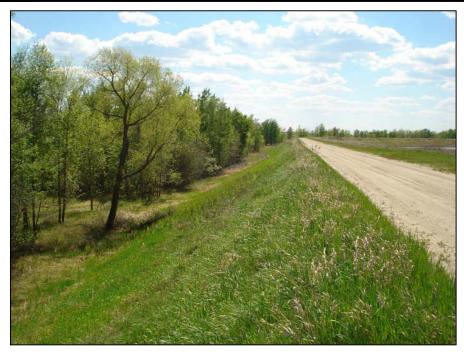
3-5
GENERAL DOWNSTREAM SLOPE ALONG EASTERN DIKE

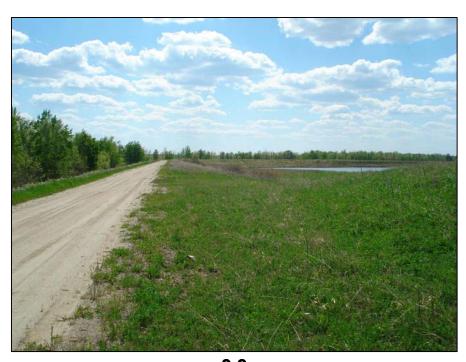
3-6 VIEW FROM EASTERN DIKE LOOKING SOUTHWEST TOWARDS INDUSTRIAL SOLID WASTE AREA AND INACTIVE BOTTOM ASH POND

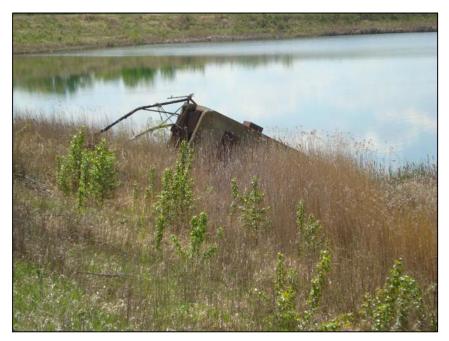
3-7 OLD DISCHARGE STRUCTURE ALONG SOUTHEASTERN DOWNSTREAM TOE

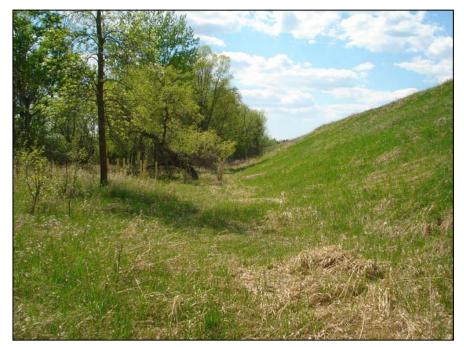
3-9
GENERAL SITE PHOTO ALONG SOUTHERN DOWNSTREAM TOE LOOKING WEST (NEAR MONITORING WELLS NDM248/24D)

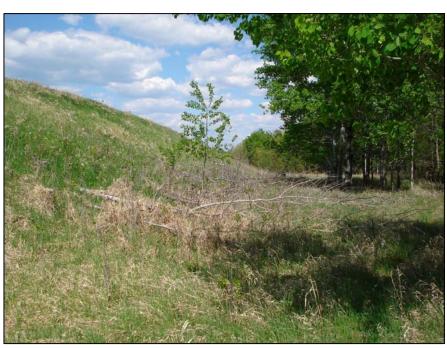
3-10 General site photo along southern downstream toe looking east

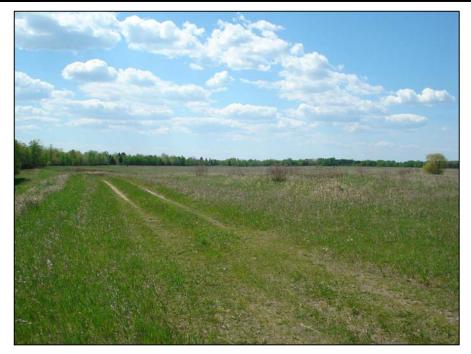
3-11
VIEW FROM SOUTHERN DIKE LOOKING WEST TOWARDS INACTIVE FLY ASH POND

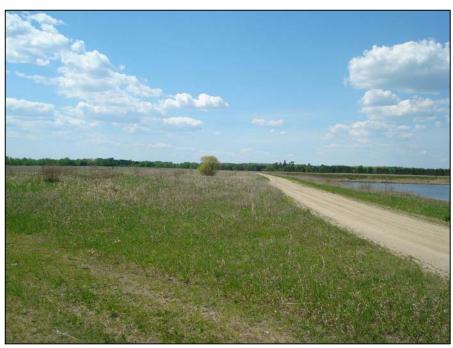
3-12 VIEW FROM SOUTHERN DIKE LOOKING NORTH TOWARDS INACTIVE FLY ASH POND AND DIVIDING DIKE

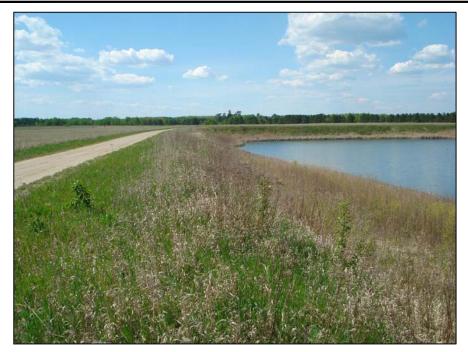
3-13
TYPICAL DOWNSTREAM SLOPE FROM WESTERN (DIVIDING) DIKE LOOKING NORTH
